Original Article**The Effect of Finish Line Design on the Fracture Resistance of Zirconia Copings**

Purpose: The purpose of this in vitro study was to evaluate the effect of two marginal designs (shoulder 90°, shoulder 135°) on the fracture resistance of zirconia copings.

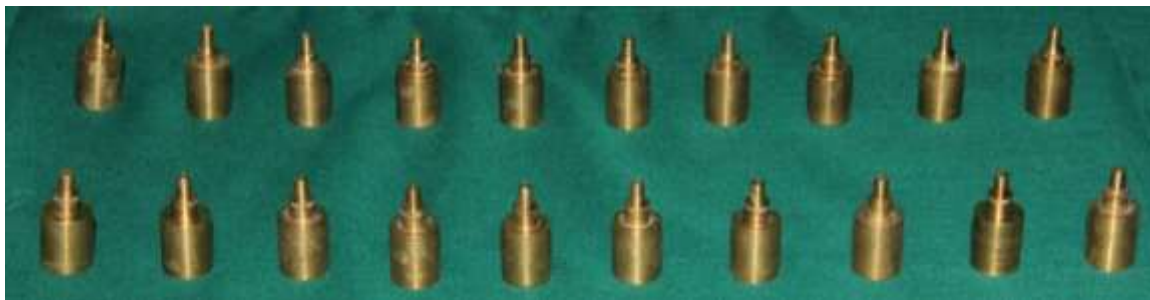
Figure 1: Master dies.

In this in vitro study, 20 standard brass dies were designed and prepared by CNC milling machine (CNC350; Arix Co. Tainan Hsin, Taiwan) (Figure 1). Preparation was standardized using a wide smooth continuous margin, free of any irregularities. Each die was made to provide 6° occlusal convergence angle, and axial occluso-gingival height of 6.4mm, 5.5mm base width, and 1.2mm margin thickness; half of the

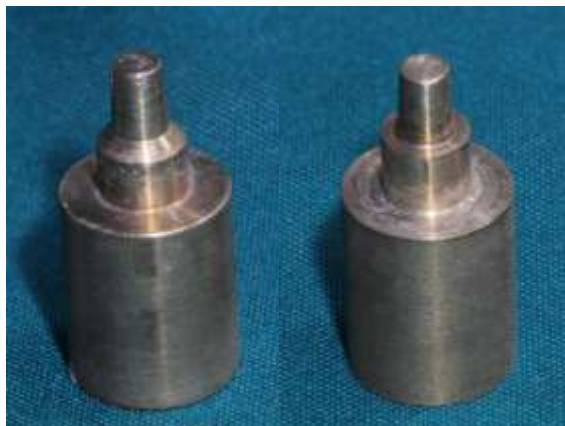
Figure 2a: Master die with 135° shoulder margin. **b:** Master die with 90° shoulder margin.

samples had a 135° shoulder margin (Figure 2a), and the other half with a 90° shoulder margin (Figure 2b) (n=10). The brass dies were visually inspected for any possible irregularities by a single operator utilizing a binocular loupes (Heine HR-C 2.5*; Heine, Herrsching, Germany).

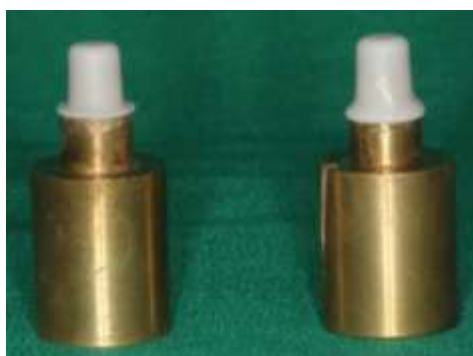
Figure 3: Zirconia copings placed on master dies.

The copings were cemented with glass-ionomer luting cement (GC Corporation, Tokyo, Japan) which was mixed based on the manufacturer's instruction. It was inserted into the crown by use of an applicator and the copings were mounted on brass dies (Figure 3). The excessive cement was removed by using a probe and the final samples were stored in normal saline at room temperature for 24 hours.
