Original Article

A Special Design to Facilitate Retrieval of Cement-Retained Zirconia-Based Implant-Supported Restorations

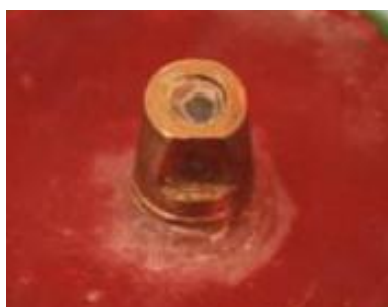
Figure 1: Brass die embedded in acrylic resin block

An implant analog (DioCorp, Busan, South Korea) with the diameter of 5mm and the height of 6.5mm was connected to a straight titanium abutment (DioCorp, Busan, South Korea) with the diameter of 5mm, the height of 7mm, and the collar height of 3mm. This complex was used as a pattern to mill 33 brass dies exactly similar to model by using a lathe (CNC 350; Arix Co; Tainan Hsin, Taiwan). A total of 9.5mm of each sample was embedded in an acrylic resin block vertically (Figure 1). Subsequently, the dies were sprayed with scan spray and scanned using a 3D-laser scanner (3Shape D810; 3Shape, Copenhagen K, Denmark). The data were transferred to CAD software (3Shape's CAD Design software; 3Shape, Copenhagen K, Denmark). By considering a 30- μ m space for the cement, a mandibular molar coping with a uniform thickness of 1mm around was designed. Twenty-two zirconia copings were milled from pre-sintered Y-TZP blanks (IPS Emax Zir CAD, Ivoclar Vivadent) in a milling machine (inLab MC, Sirona) and then sintered. Eleven samples were used for the control group and the other eleven samples were used for the second group (conventional). A 2mm diameter circle was drawn in the center of the occlusal table in the second group. Eleven zirconia frameworks were designed with the same sizes and shapes as those of the first and second groups except that a ledge was existed in the location of the screw access channel (Figure 2). The ledge was 1 mm in thickness and 1.5mm in height and it was located around a 2mm hole in the center of the occlusal surface. A silicone index was used to standardize porcelain application to all the samples. The crowns were then cemented by using zinc oxide-eugenol cement (TempBond; Kerr Mfg Co., Romulus, MI) to their corresponding dies. A 20-N load was ap-

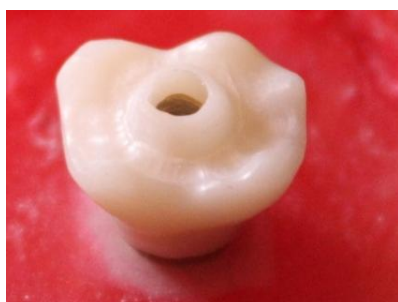
Figure 2: The ledge designed in the zirconia framework in the location of screw access channel of the third group

In our previous study [23], we designed a ledge in the framework of cement-retained implant-supported metal ceramic restorations in the location of screw access hole to support remaining porcelain after perforation of framework. This design has the advantages of cement-retained restoration as well as the convenience of retrieval [23]. Due to increasing demands for all ceramic restorations in the current study, zirconia based implant supported crowns were tested. The purpose was

In some clinical situations, to retrieve the restoration, making a hole on the occlusal surface of the cement-retained implant-supported restoration is inevitable due to screw loosening or porcelain fracture. In the current research, a ledge was designed in the framework of the implant-supported zirconia-based cement-retained restoration. The goal of this special design was to prepare a support for the remaining veneering porcelain after creating a hole in the restoration. Analyzing the values in the present study showed that the crowns with the special design had better fracture resistance than those with the conventional design perforated by creating an access hole on their occlusal surface. Therefore, this feature may be used in case of high risk for screw loosening in patients with high force factors.

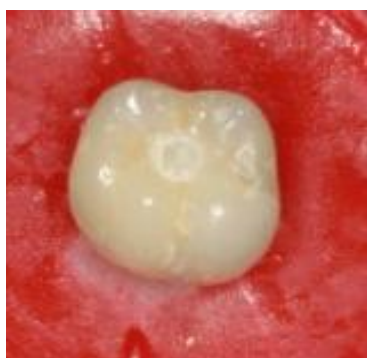
Figure 3: The holes in groups 2 and 3

plied during cementation for 15 minutes. A hole was prepared in the location of the abutment screw access channel in group 2 by using a 2 mm zirconia bur (Kom-et diamond bur, Lemgo, Germany) on a high-speed handpiece. Then the holes in groups 2 and 3 (designed in the framework) were filled with a photo-polymerized composite resin (3M ESPE Dental Products, Canada) (Figure 3). Afterward, all the crowns underwent thermal cycling for 500 cycles from 50°C to 65°C for 30 seconds with 12-second intervals to simulate oral conditions [24]. Finally, all the specimens were subjected to vertical static compressive load by using a universal testing machine (Zwick-Roell Z020; Zwick Gmb H & Co. KG, Ulm, Germany) until they were fractured. The force was applied perpendicular to the occlusal surface in the central part of the crown by using the rounded edges of the loading piston a rate of 2 mm/min.
