Original Article

## The Effect of 1.5 Tesla MRI on Microleakage and Thermal Stability of Stainless Steel and Titanium Orthodontic Brackets: An *in vitro* Study

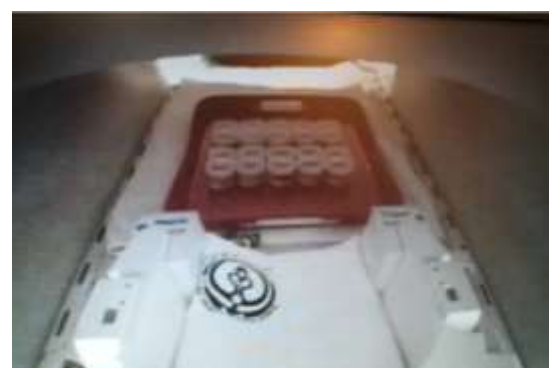
**Figure 1:** The case subgroups were exposed to 1.5 tesla MRI

The teeth were randomly divided into two groups (n= 20) based on bracket type, with each group further subdivided into control and case subgroups (n=10). The case subgroups were exposed to 1.5 T MRI using a 1.5 Tesla MRI unit (Avanto, Siemens, Germany) for 20 minutes, while the control subgroups were not exposed [38]. The MRI scanning parameters are outlined in Table 1. The samples in the case groups were positioned to maintain consistent bracket orientation during exposure (Figure 1).

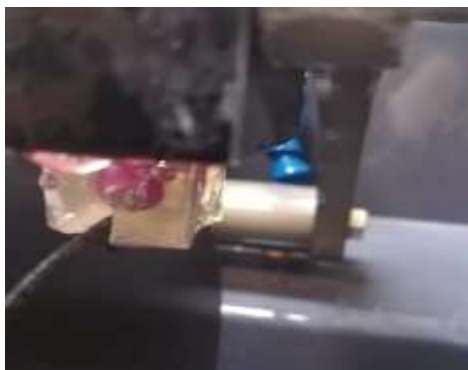
**Figure 2:** Sectioning of epoxy resin blocks was carried out using a low-speed diamond saw

The teeth were coated with two layers of nail varnish, leaving a 1mm margin around the bracket edges. Samples were immersed in 0.5% basic fuchsin dye solution (Labtron, Tehran, Iran) for 24 hours at room temperature. After removal from the solution, the teeth were rinsed with distilled water, the superficial dye was removed with a brush and the teeth were left to dry. The samples were embedded in epoxy resin blocks according to the direction of sections [39]. Sectioning was performed using a low-speed diamond saw (Figure 2). The sections were examined under a stereomicroscope at 40× magnification (Figure 3). The microleakage measurements were directly recorded using an electronic digital caliper (GuangLu Measuring Instrument Co. Ltd, Shanghai, China) by a single blinded observer.
