Original Article

Comparative Evaluation of Crack Propagation During Root Canal Preparation in Primary Molar with Manual Instrumentation, ProTaper Universal and ProTaper Next Rotary File Systems: An *in vitro* Study

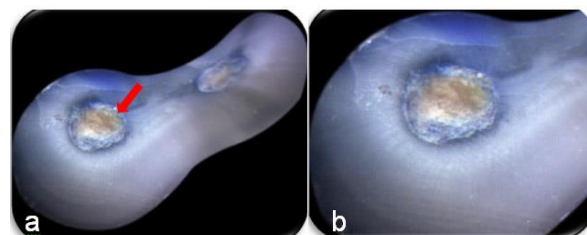
Figure 1: Specimen showing, **a:** Craze line that is unstained, extends from outer wall without connecting to canal lumen and not caused due to preparation, **b:** Magnified view

Craze lines were classified as all additional lines, including those that extended from the outer root surface into the dentin but did not enter the root canal space or any surface of the root canal wall (Figure 1).

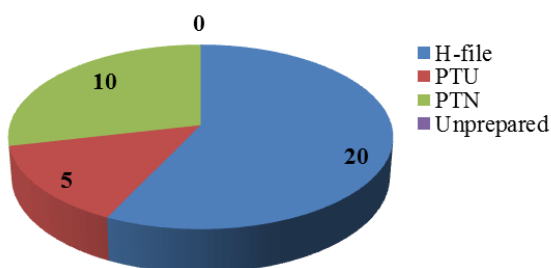
% of root canals with microcracks

Figure 2: Percentage (%) of root canals presenting with dentinal microcracks in the four groups (H file – Hedstrom file, PTU - ProTaper Universal, PTN – ProTaper Next)

In present study, 80 root canals (mesial) were selected from extracted primary maxillary and mandibular molars (Figure 2).

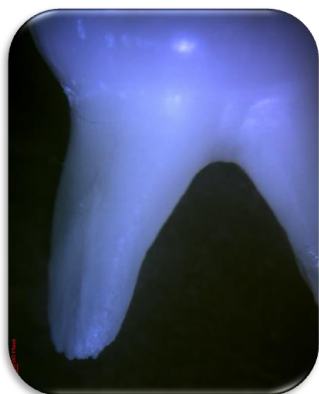
Figure 3: Pre-operative assessment of root surfaces under stereomicroscope at 10×

All the samples were screened preoperatively under the stereomicroscope at 10× magnification to exclude teeth with any external cracks or fractures. No such defects were found on examination (Figure 3).

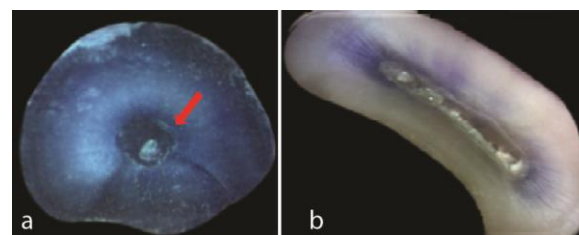
Figure 4: Specimens of Group I showing, **a:** Complete crack in apical section, **b:** No crack

In Group I after instrumentation with H files, 4 out of 20 (20%) root canals presented with dentinal microcracks.

This was statistically significant ($p= 0.016$) (Figure 4). In Group II prepared with ProTaper Universal NiTi

In Group I prepared with H files, 4 (20%) root canals presented with complete cracks in the apical third. This was statistically significant ($p = 0.016$). ProTaper Universal group did not show any cracks in apical third while 1 (5%) root canal of ProTaper Next group showed an incomplete crack in the apical third ($p = 0.016$) (Table 2).

In our study, complete cracks were seen only in the H file group in the apical section. The root canals in this group were instrumented till file size #30 (.02), which has an apical diameter of 0.30 mm. This apical tip diameter is greater than the tip diameter of the last file used at working length of the other two rotary file systems (S2=0.20mm and X2= 0.25mm). This may have contributed to increased stress and hence the complete crack seen in the H file group. Dentinal microcracks, found in the other two groups prepared with ProTaper Universal and ProTaper Next, were incomplete in nature

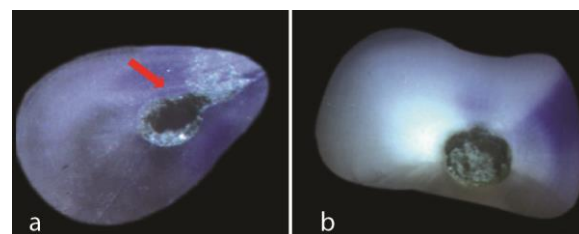
Figure 5: Specimens of Group II showing, **a:** Incomplete crack in coronal section, **b:** No crack

rotary files, 1 out of 20 (5%) root canals presented with dentinal microcracks (Figure 5). In Group III prepared with ProTaper Next NiTi rotary files, 2 out of 20 (10%) root canals showed dentinal microcracks (Figure 6). In Group IV that was unprepared, no cracks were detected (Figure 7).

Cracks were absent in the coronal third in the group prepared with H files. One (5%) root canal showed incomplete crack in Group II prepared by ProTaper Universal rotary files while 2 (10%) root canals showed incomple-

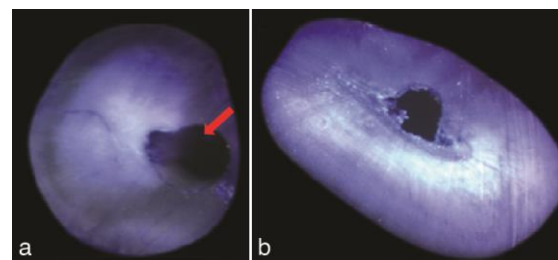
Figure 6: Specimens in Group III showing, **a:** Incomplete crack in coronal section, **b:** No crack

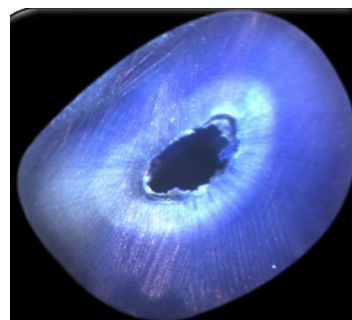
Figure 7: Specimen in Group IV showing no crack

In this study, there was absence of dentinal cracks in the negative control (unprepared) group, which was in accordance to the study by Yoldas *et al* [27]. Optical coherence tomography and computed microtomography are some of the other methods for the inspection of dentinal cracks [20, 28] that do not require root sectioning for crack examination. However, divergent results were observed for the above methods. Thus, stereomicroscopy, which is one of the most common methods of assessment, was used in our study. Özyürek *et al.* [12] compared dentinal cracks in primary teeth caused by Reciproc, WaveOne Gold, and ProTaper Next NiTi rotary files. Root canals were prepared using RPC R25 (25/.08), WaveOne Gold Primary (25/.07) file and ProTaper next X1 (17/.04) and X2 (25/.06) respectively in the three groups. Dentinal cracks were found in all three file groups. In terms of the observed total dentin fracture, the WaveOne Gold and ProTaper Next groups had significantly less dentinal cracks than the Reciproc group. In comparison to the WaveOne Gold and ProTaper Next groups, the Reciproc group had more dentinal fractures in the apical area. Our study's findings show that all three tested groups of H files, ProTaper Universal, and ProTaper Next files had dentinal cracks. Interestingly, in contrast to the study by Özyürek *et al.* [12], highest percentage of cracked root canals (20%) were observed in the H file group followed by ProTaper Next group with 10% cracked root canals while only 5% root canals in ProTaper Universal group were cracked.
