Original Article**The Effects of New Design of Access Hole on Porcelain Fracture Resistance of Implant-Supported Crowns**Reza Derafshi ^a, Mitra Farzin ^a, Masoumeh Taghva ^b, Hossein Heidary ^b, Berivan Atashkar ^b^aDept. of Prosthodontics, School of Dentistry, Shiraz University of Medical Sciences, Shiraz, Iran.^bPostgraduate Student of Prosthodontics, Dept. of Prosthodontics, School of Dentistry, Shiraz University of Medical Sciences, Shiraz, Iran.**KEY WORDS**Dental Implants;
Cement-retained;
Fracture Resistance;
Metal Ceramic Crowns**ABSTRACT****Statement of the Problem:** One disadvantage of cement-retained crowns is the lack of predictable irretrievability. This problem can be overcome through designing a screw access hole in the metal substructure of cement-retained restoration and using porcelain stain to define this area.**Purpose:** This study aimed to evaluate the influence of existence of screw access hole on porcelain fracture resistance of metal-ceramic implant-supported crowns.**Materials and Method:** Thirty six standardized metal-ceramic crowns were fabricated and divided into 3 groups (n=12); group 1 conventional cement-retained metal-ceramic crowns as control gr

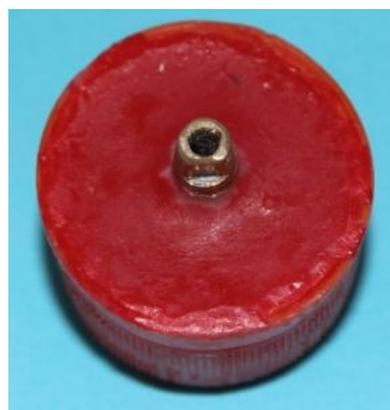
A 5×6.5 implant analog (Dio Corp.; Busan, Korea) was connected to a straight abutment. Then it was duplicated as 36 brass dies by using a lathe (CNC 350; Arix Co., Tainan Hsin, Taiwan). Then, five millimeters of each die was embedded vertically in an acrylic resin block with the aid of a dental surveyor (Figure 1).

Figure 1: Brass die embedded in acrylic resin block

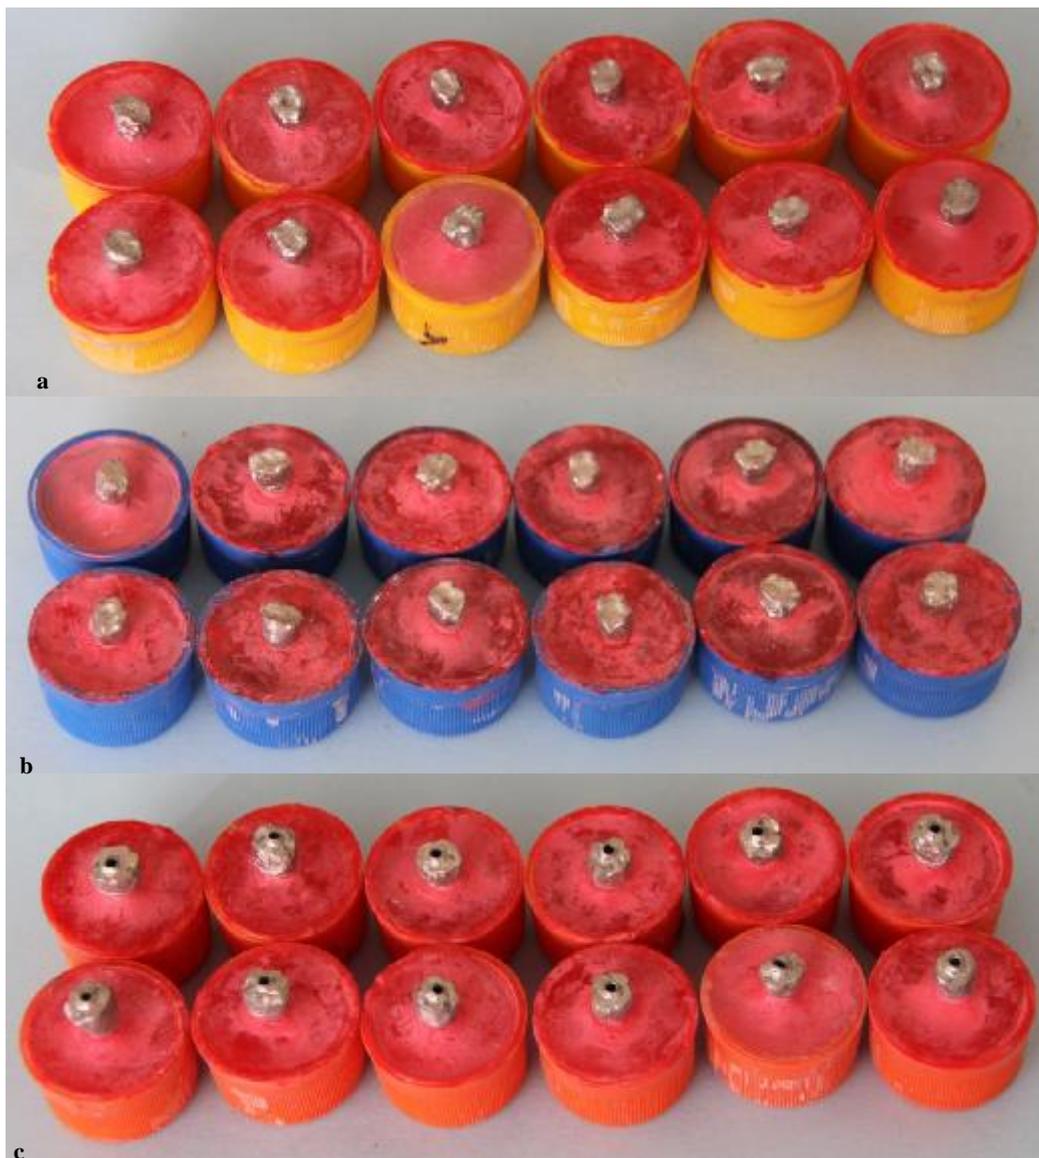
Subsequently 36 metal ceramic crowns were fabricated with 3 designs; group 1 consisted of 12 conventional metal-ceramic crowns with cement-retained restorations as control group (Figure 2a), group 2 included 12 crowns with porcelain stain used to define the location of screw access channel (Figure 2b). Group 3 was constituted of 12 crowns during framework fabrication of which, a ledge was designed in wax-up in the location of screw access channel (Figure 2c). The ledge was 1.5 mm in height and 1 mm in thickness around a 2-mm hole in the center of occlusal surface (Figure 3). This area was defined in the crown by using porcelain stain.

Figure 2a: 12 conventional metal-ceramic implant frameworks of group 1 **b:** Group 2; implant frameworks **c:** Group 3; implant frameworks

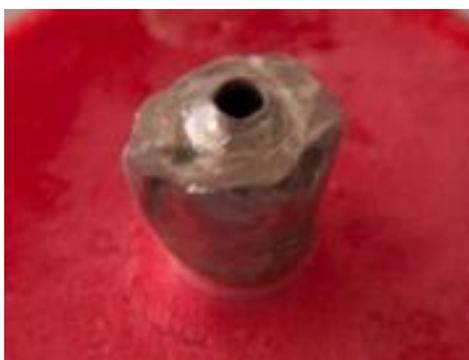
Figure 3: The ledge designed in the location of screw access channel of the third group of metal ceramic crowns

- Presence of screw access opening in cement-retained implant restoration would not compromise the fracture resistance.
- Designing a ledge in the framework of cement-retained implant restorations in the location of screw access opening could be a useful method to retrieve restoration, without compromising its strength.

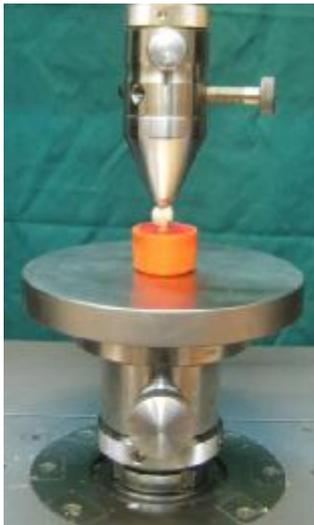
Finally, all specimens were thermocycled for 500 cycles between 50-65°C for 30 seconds with 12-second intervals according to the literature. [31-32] Each specimen was subjected to vertical compression load by using a universal testing machine (Zwick-Roell Z020; Zwick Gmb H & Co. KG, Ulm, Germany) (Figure 4).

Figure 4: Frontal view of specimen positioned in the universal testing machine

The force was applied perpendicular to the occlusal surface in the central part of the restoration with a cross-head speed of 2mm/min. In order to simulate the contact established by the opposing tooth, the rounded edges of the loading pin simultaneously contacted the triangular ridges of both buccal and lingual cusps of the crowns (Figure 5). The specimens were loaded to failure. Maximum values of loads at failure were recorded for each specimen. Mean values of fracture resistance for all groups were calculated and compared by using one-way ANOVA. The level of statistical significance was set at $\alpha=0.05$.

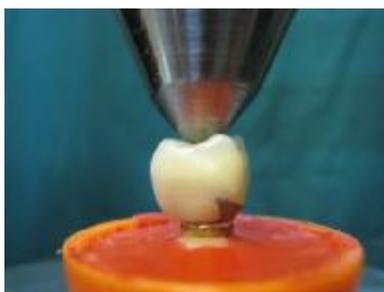
Figure 5: Close up view of loading apparatus
