Original Article

Effect of a Home Bleaching Agent on the Fracture Toughness of Resin Composites: using short rod design

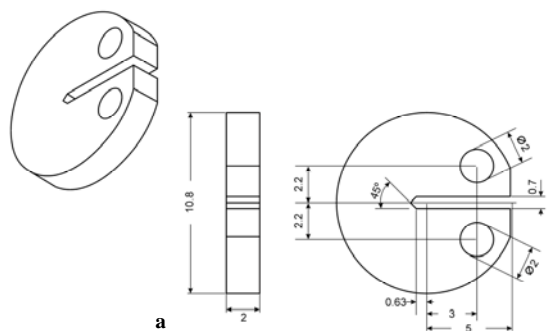
Three resin composites and one home bleaching agent was used in this in vitro study (Table 1). A custom-made, polytetrafluorethylene (PTFE) split mould was used to prepare a total of 72 disk-shaped specimens (n=8). A pre-crack was created in the mini-compact specimen with a razor blade as described by Kovarik et al. [17] in accordance with ASTM Designation: E399-83 [18]. Figure 1a shows a schematic representation of the specimen configuration along with all dimensions, and Figure 1b displays the PTFE split mould assembly with a razor blade

Figure 1a A schematic representation of the specimen configuration along with all dimensions **b** A photo of PTFE split mould assembly with a razor blade placed into the notch during specimen preparation

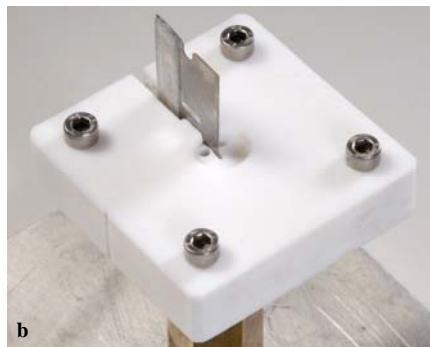
placed into the notch during specimen preparation.

The split mould was assembled using guide screws. The mould was filled with the resin composite and covered by plastics matrix strips and glass plates under gentle hand pressure in order to extrude excess material. A new razor blade was used to create a sharp pre-crack in the notch during polymerization of the resin composite. The materials were cured according to the manufacturers’ recommended exposure times using an LED curing light with a wavelength range of 440-480 nm at an output of 1500mW/cm² (Radian plus LED; SDI, Bayswater, Vic, Australia). Each specimen was removed from the mould and light-cured on the opposite side for an additional period of the recommended exposure time and then placed in distilled water for 30 min. After polymerization, in order to obtain a flat surface, the edges of the specimens were ground by gentle wet grinding using 1500-grit silicon carbide paper.

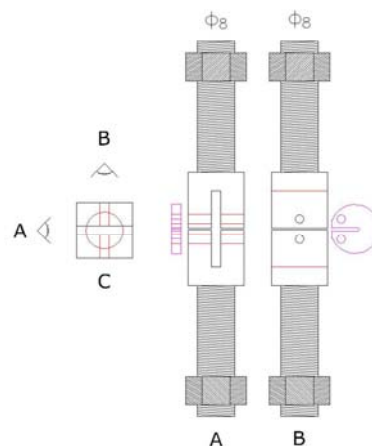
The specimens of each material were randomly divided into 3 groups of 8 and stored in distilled water at 37°C either for 24 h or 21 d. K_{Ic} Baseline measurement was performed after 24 h of immersion. The specimens in the second group were kept in distilled water for 21 d. The specimens in the third group were designated as the treatment group and immersed in a plastic tray fabricated to hold the specimens during the application of bleaching agent, Polanight (SDI; Victoria, Australia), for a period of 21 d, for 2 h a day. Evidently faulty specimens having voids or cracks were discarded. The thickness of each specimen was adjusted to 2 mm (±0.2) and measured using Dental Metal Gauge 04070 (Hygeia Dental Co. Ltd.; Hong Kong, SAR China). The specimens were secured in universal testing machine (Zwick/Roll Z020; Zwick GmbH & Co, Germany) using guide pins placed through specimens holes (Figure 2).

Figure 2 A schematic representation of fracture toughness testing apparatus under tensile loading. Prior to applying load, specimen is secured in Universal testing machine with guide pins placed through specimen’s hole.

Tensile loading was applied at a crosshead speed of 0.05 mm/min; the maximum load at specimen failure was recorded and the K_{Ic} (MPa.M^{0.5}) was calculated using the following formula: $K_{Ic} = P_c \times f(a/w) / BW^{0.5}$

Where, P_c = maximum load at specimen fracture, f(a/w) = a function of a and w B = specimen thickness, W = dimension from the un-notched edge of the specimen to the plane centreline of the loading holes.

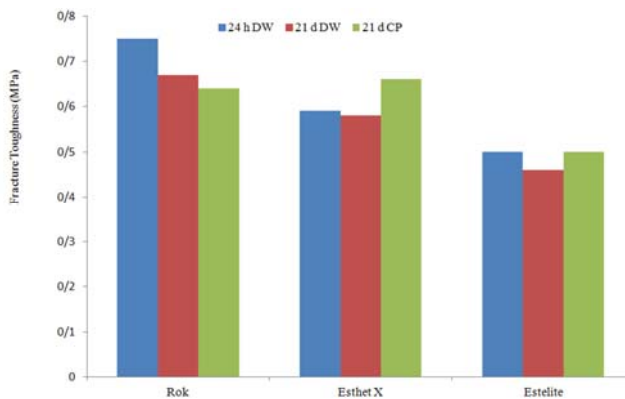
Figure 3 Fracture toughness of all materials including control and treatment groups

Immersion in distilled water for 21 d (Figure 3) was associated with a decrease in the fracture toughness of almost all materials in a significant level for Rok but a slight decrease of Esthet X. Rok was adversely affected by aging in distilled water and even more by carbamide peroxide. A slight decrease was observed for Esthet after aging in distilled water and a significant increase after treatment by carbamide peroxide. Estelite showed a slight decrease after 21 days of immersion in distilled water but no differences in K_{Ic} after treatment by carbamide peroxide was observed (Table 2 and Figure 3).

As shown in Table 2 and graphically in Figure 3, Rok with the highest value at base line lost its toughness remarkably after 21 days of immersion in distilled water and even more with applying 10% carbamide peroxide. In contrast, Esthet X with the lower baseline value
